SUBJECT: Report of Investigation of Violent Chemical
Reaction in F₂ Surge Drum, X-344, on March 4, 1959.

REPORT OF INVESTIGATION OF VIOLENT CHEMICAL REACTION

IN F₂ SURGE DRUM, X-344 ON MARCH 4, 1959.

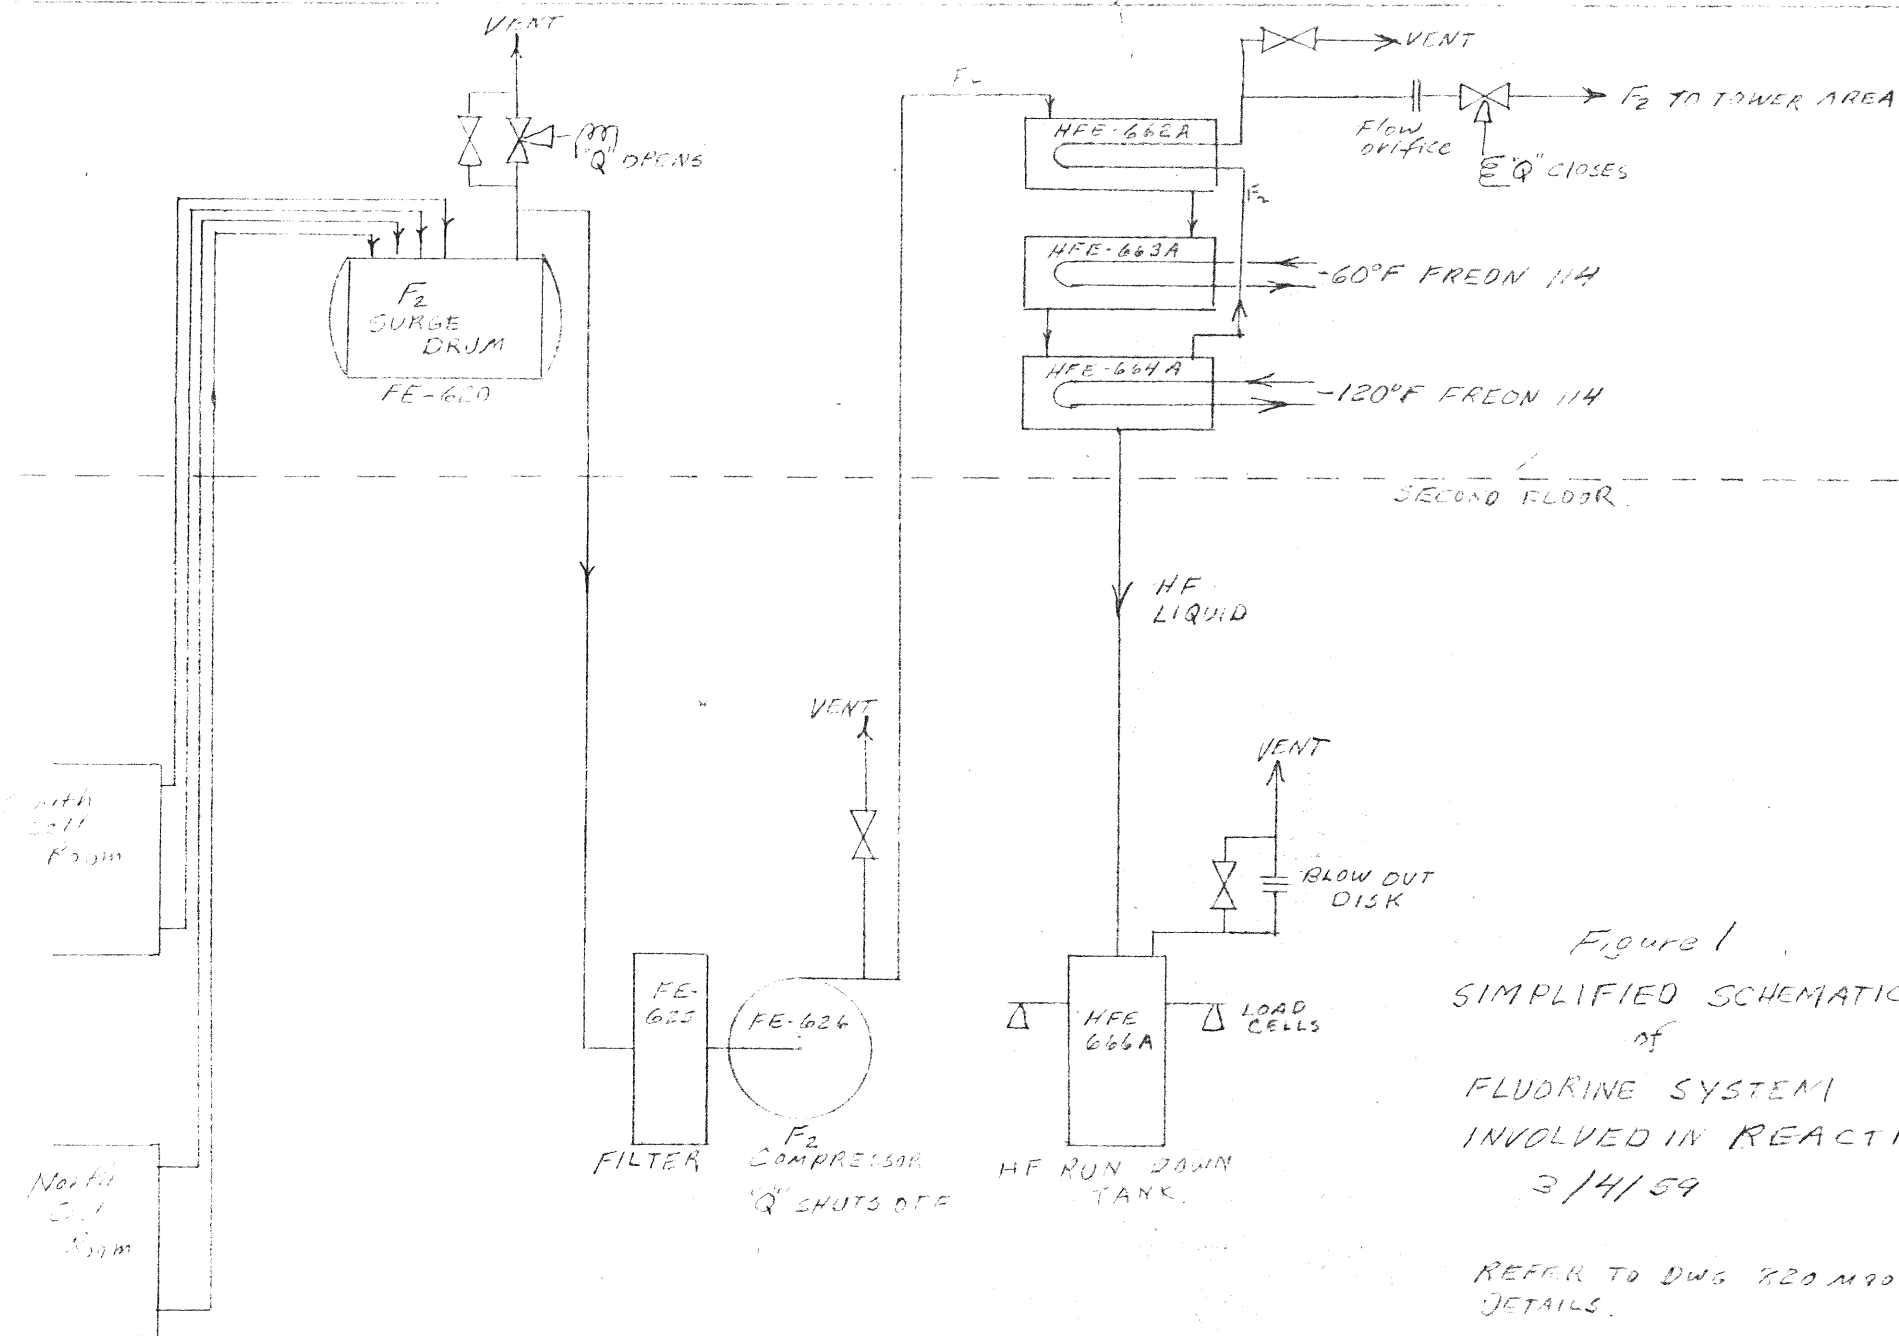
Figure 1
SIMPLIFIED SCHEMATIC
of
FLUORINE SYSTEM
INVOLVED IN REACTION
3/4/59

A simplified schematic diagram of the portion of the system actually valved in at the time of the explosion is shown in Figure 1. A more complete schematic of the entire system is available in Dwg. 820 M 90. Fluorine produced in the cell room flows through the surge tank, a mist filter, and a five-stage centrifugal fluorine compressor to the inlet of the HF condensing system, which consists of three heat exchangers in series. The first, HFE 662, is a gas-to-gas cooler in which heat in the inlet gas is transferred to the cold fluorine leaving the system. The partially cooled inlet gas proceeds to the second heat exchanger, HFE 663, where it is cooled to -60°F by a Freon-114 "brine" loop, and thence into the third exchanger where it is cooled to -120°F by a second F-114 brine loop. The outlet fluorine is metered by a flow orifice and the outlet pressure to the tower area controlled by a DEM and control valve. The HF content of the fluorine from the cells is about 15 percent; after passing through the condensers it contains about two percent. The condensed HF drains from the heat exchangers to a HF "run-down" tank, HFE 666A, from which it is periodically transferred to the HF storage tanks by nitrogen pressure. The HF run-down tank is equipped with load cells which indicate on a weight recorder in the control room.

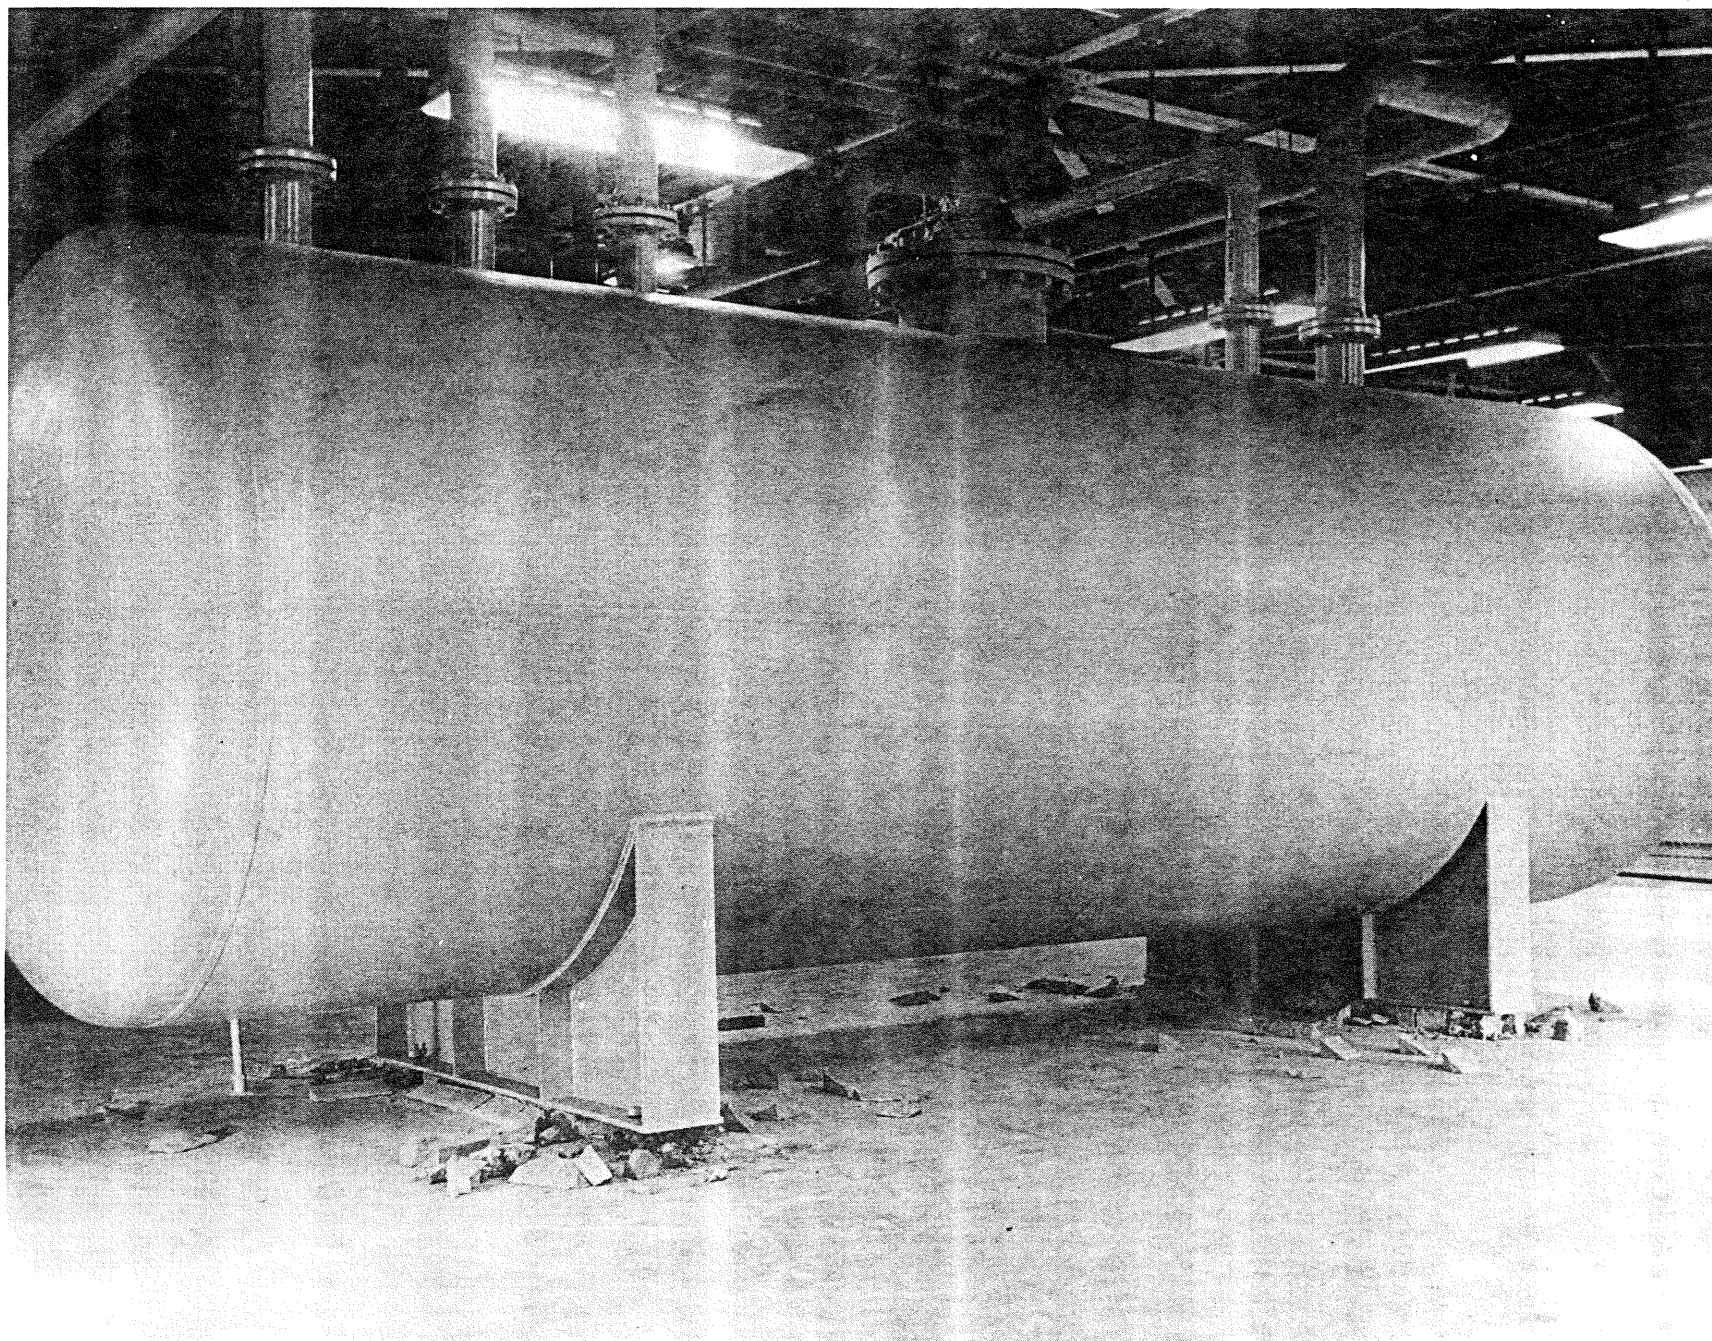
A quick inspection of the plant was made. Broken concrete grouting was noticed at the base of the F_2 surge drum. A fluorine fire was discovered at one fluorine cell outlet flange gasket. Electrolyte had blown out of the sampling valves of several fluorine cells.

a) The Mechanical Inspection Department inspected the F₂ surge drum and determined that the vessel was undamaged.

c) Liquid Freon vaporized at a rate too great to be handled by the vent system, and the vapor traveled back to the F₂ surge drum where it mixed with a large volume of fluorine, producing a violent chemical reaction. The resultant pressure surge forced large quantities of gas under the F₂-H₂ separator skirts in the fluorine cells, forced electrolyte into the hydrogen header and out some sampling valves and plugged HF feed lines to individual cells. In addition, it blew out a Teflon flange gasket at the cell-header connection of one cell, producing a minor fluorine fire.

Fig. No. 3 "Fluorine surge drum showing shattered base grouting."

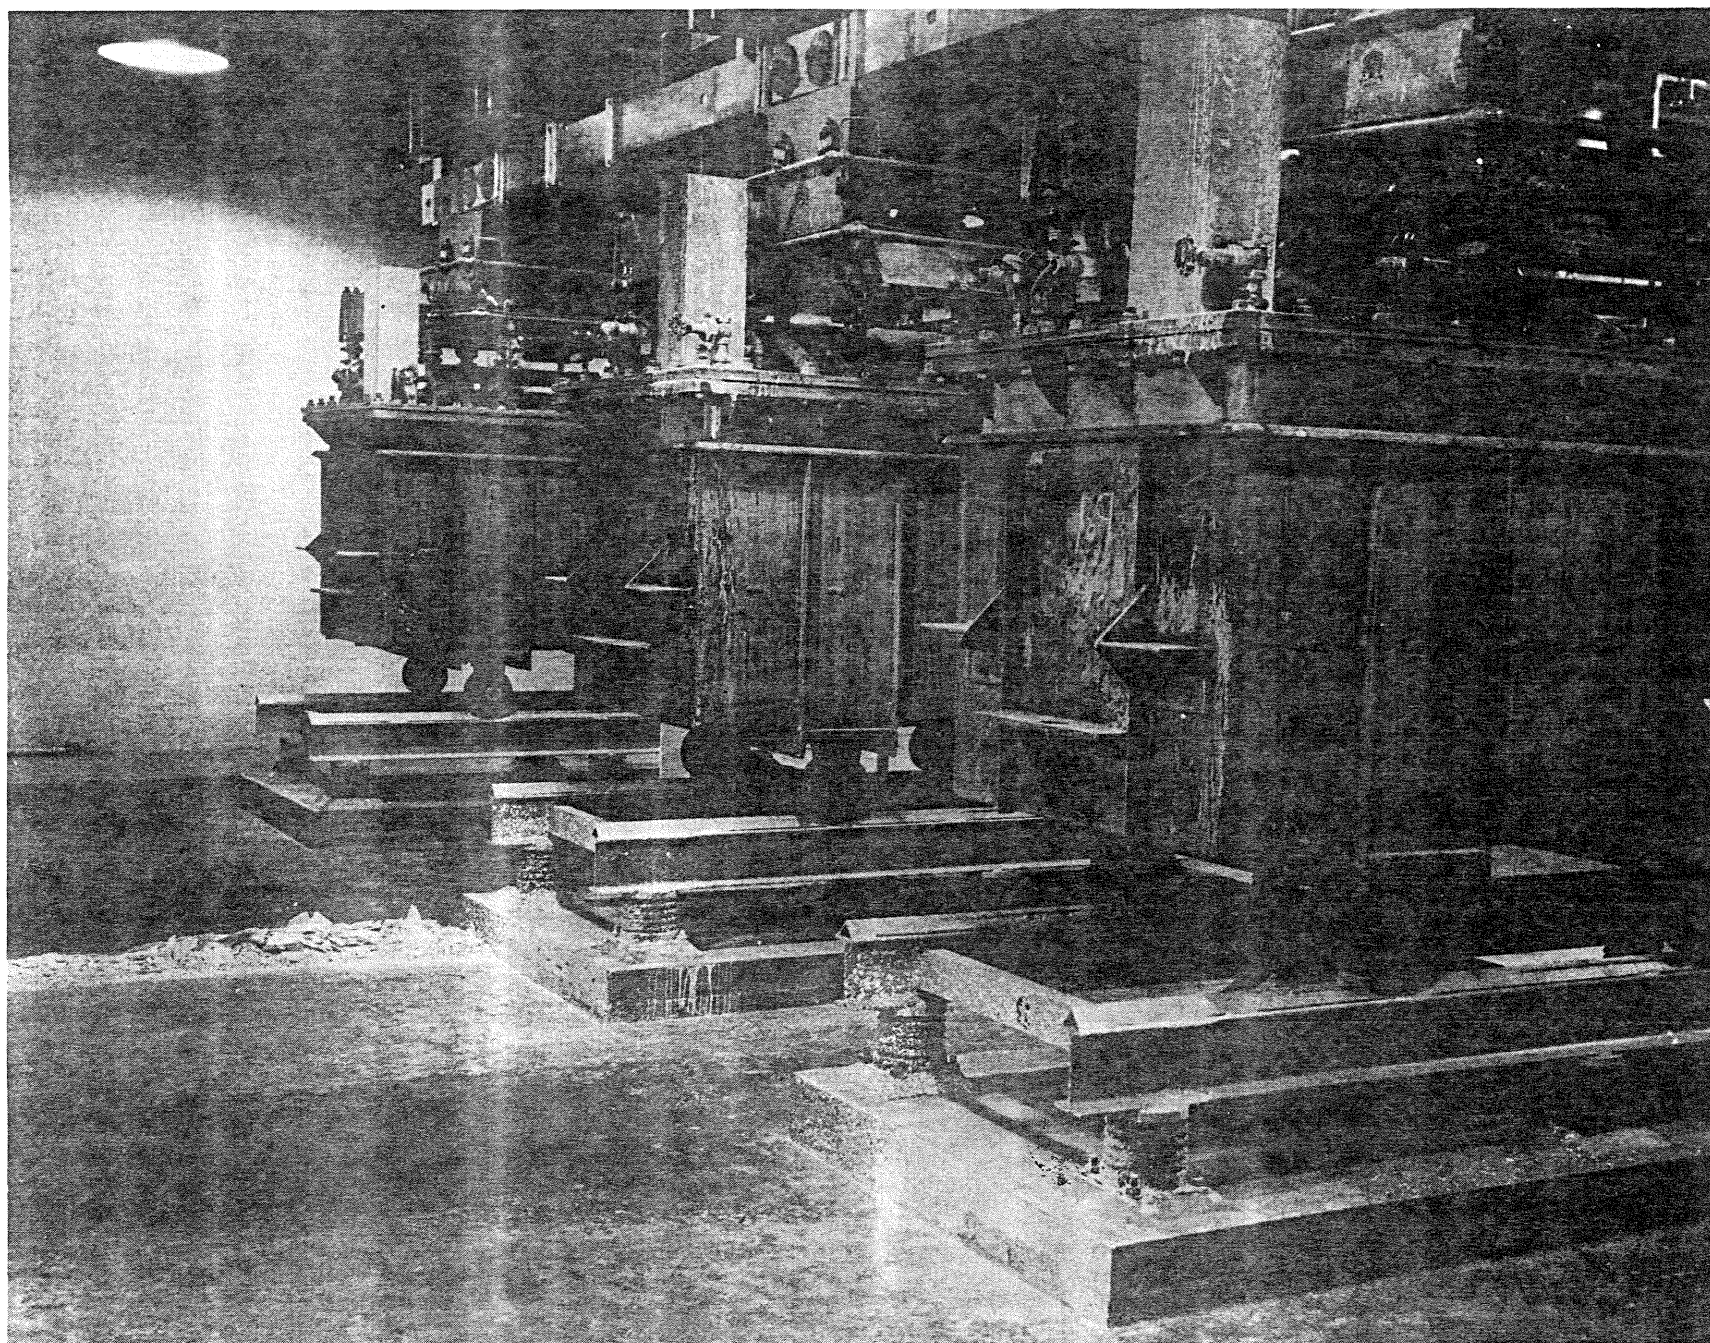
Fig. No. 4 "South fluorine generation room showing spilled electrolyte from sampling valves."

- c) That at plant start-ups and once a shift thereafter, the exact time should be marked on all recorder charts. If charts are not synchronized it is difficult to establish sequence of operation.
- d) That a positive method be used to secure all Freon valve bonnets.
- e) That all fluorine cell electrolyte sample valves be kept fully closed when not in use.

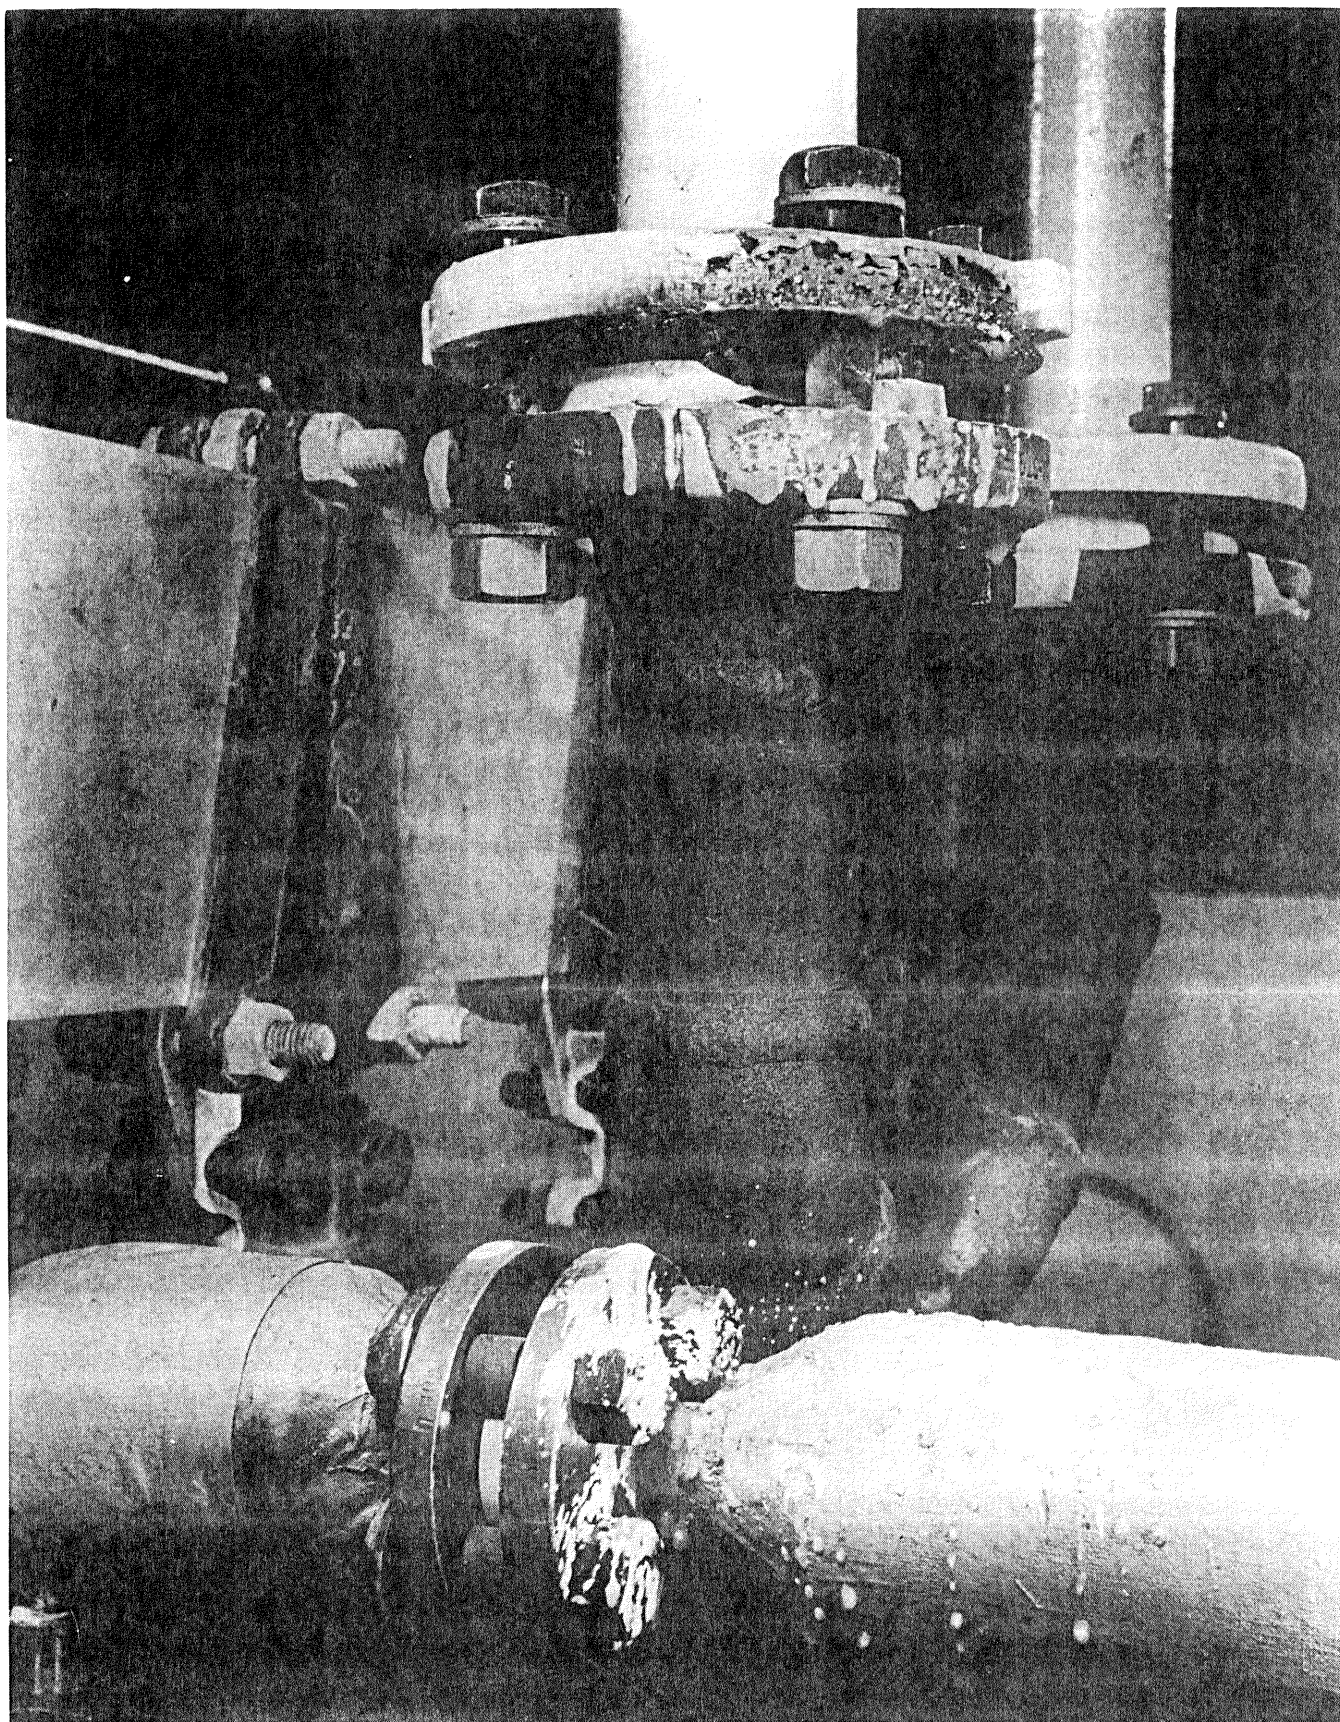
b) In addition to one gasket fire at a cell outlet flange many cells had lowered electrolyte levels, leaking flange gaskets, and plugged HF feed dip legs. There was no detectable mechanical damage to the F₂ cells. All cell room hydrogen headers and valves in use contained electrolyte.

Fig. No. 5 "Fluorine cell outlet flange where fire occurred."

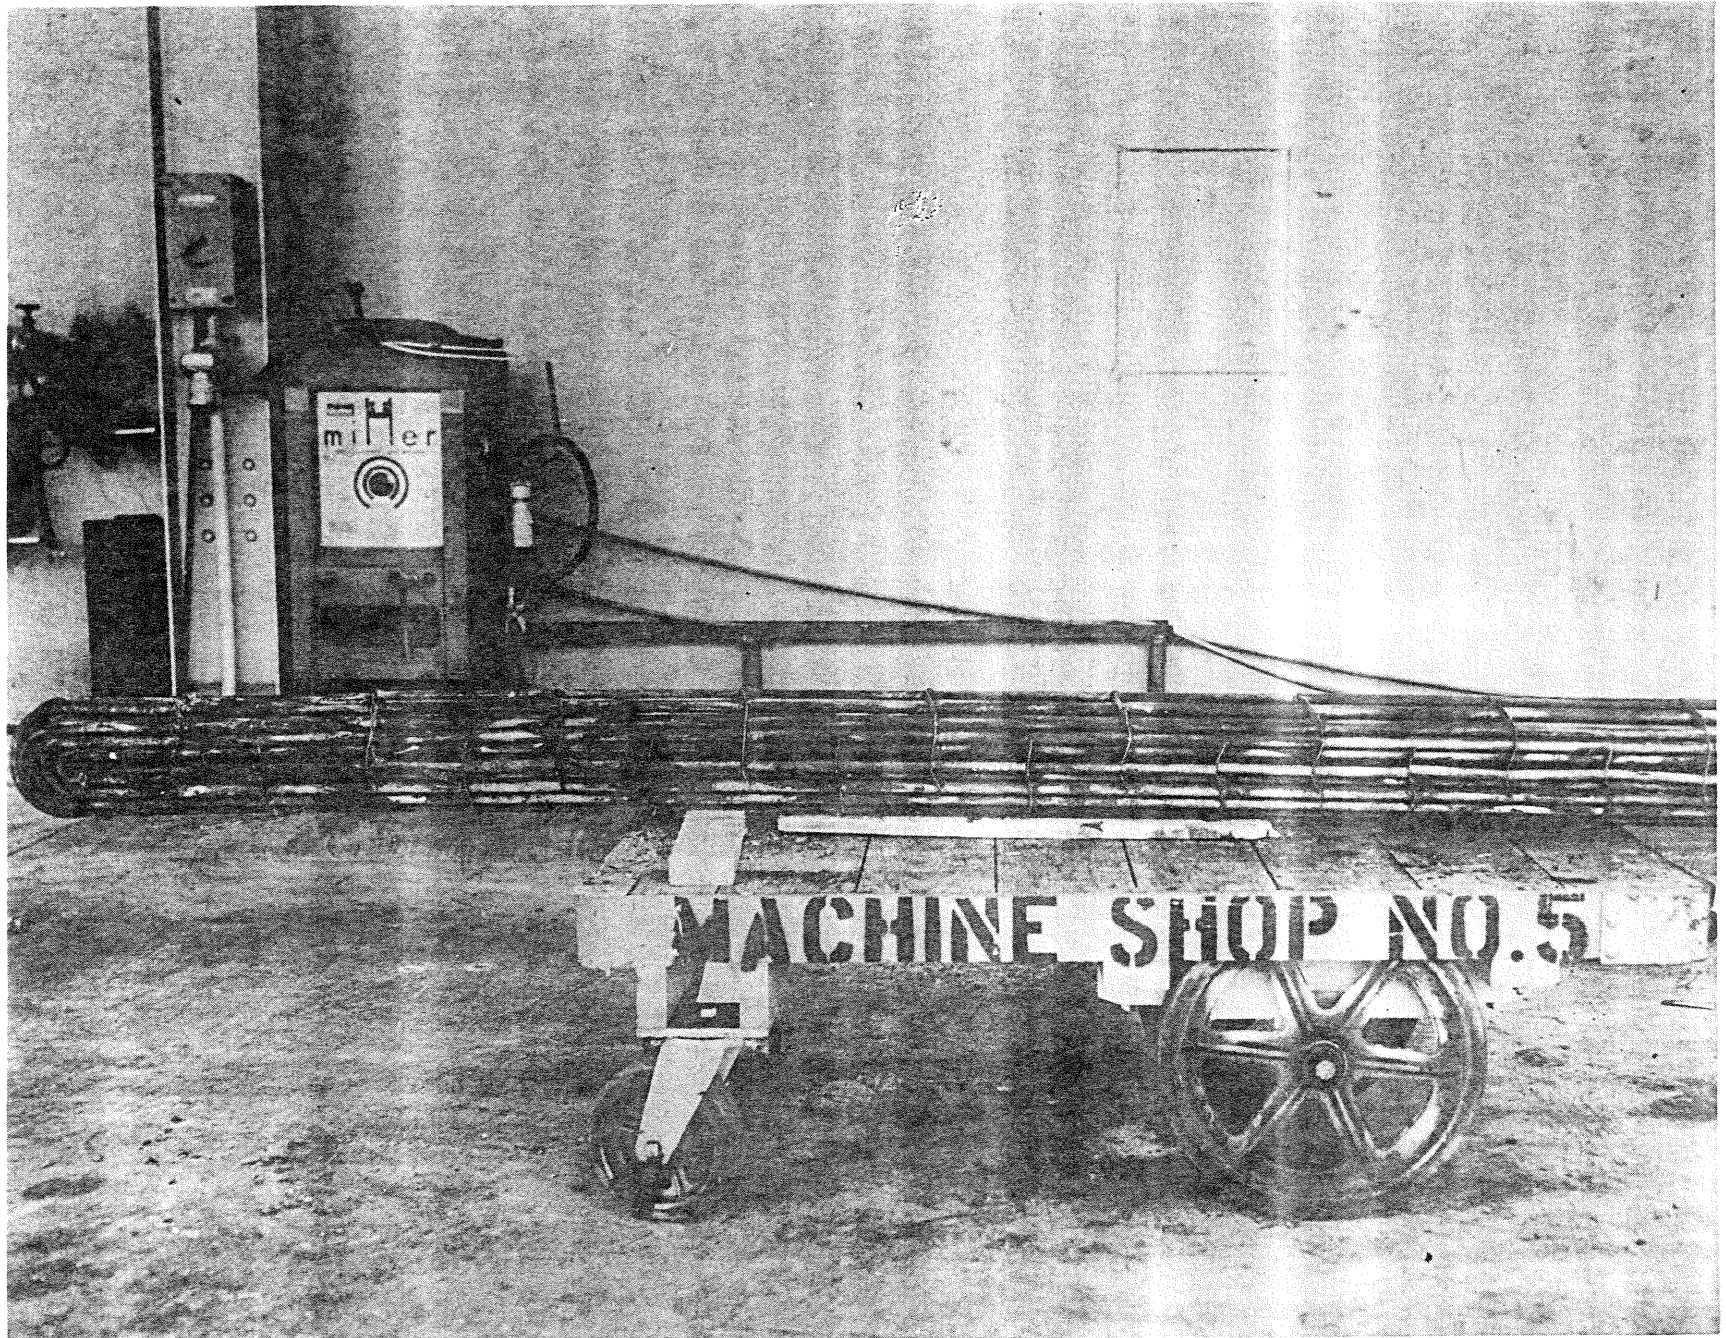
d) HF Cooler HFE 663A, which had obviously developed a major Freon leak, was removed and cut open for inspection. About four feet of the monel shell, near the F₂ inlet, had been hot enough to discolor and was slightly warped. The tube bundle was beyond economical repair. The copper spacers and monel tube supports were partially melted and copper Freon tubes were ruptured.

Fig. No. 6 "Tube bundle from gas cooler HFE663A."

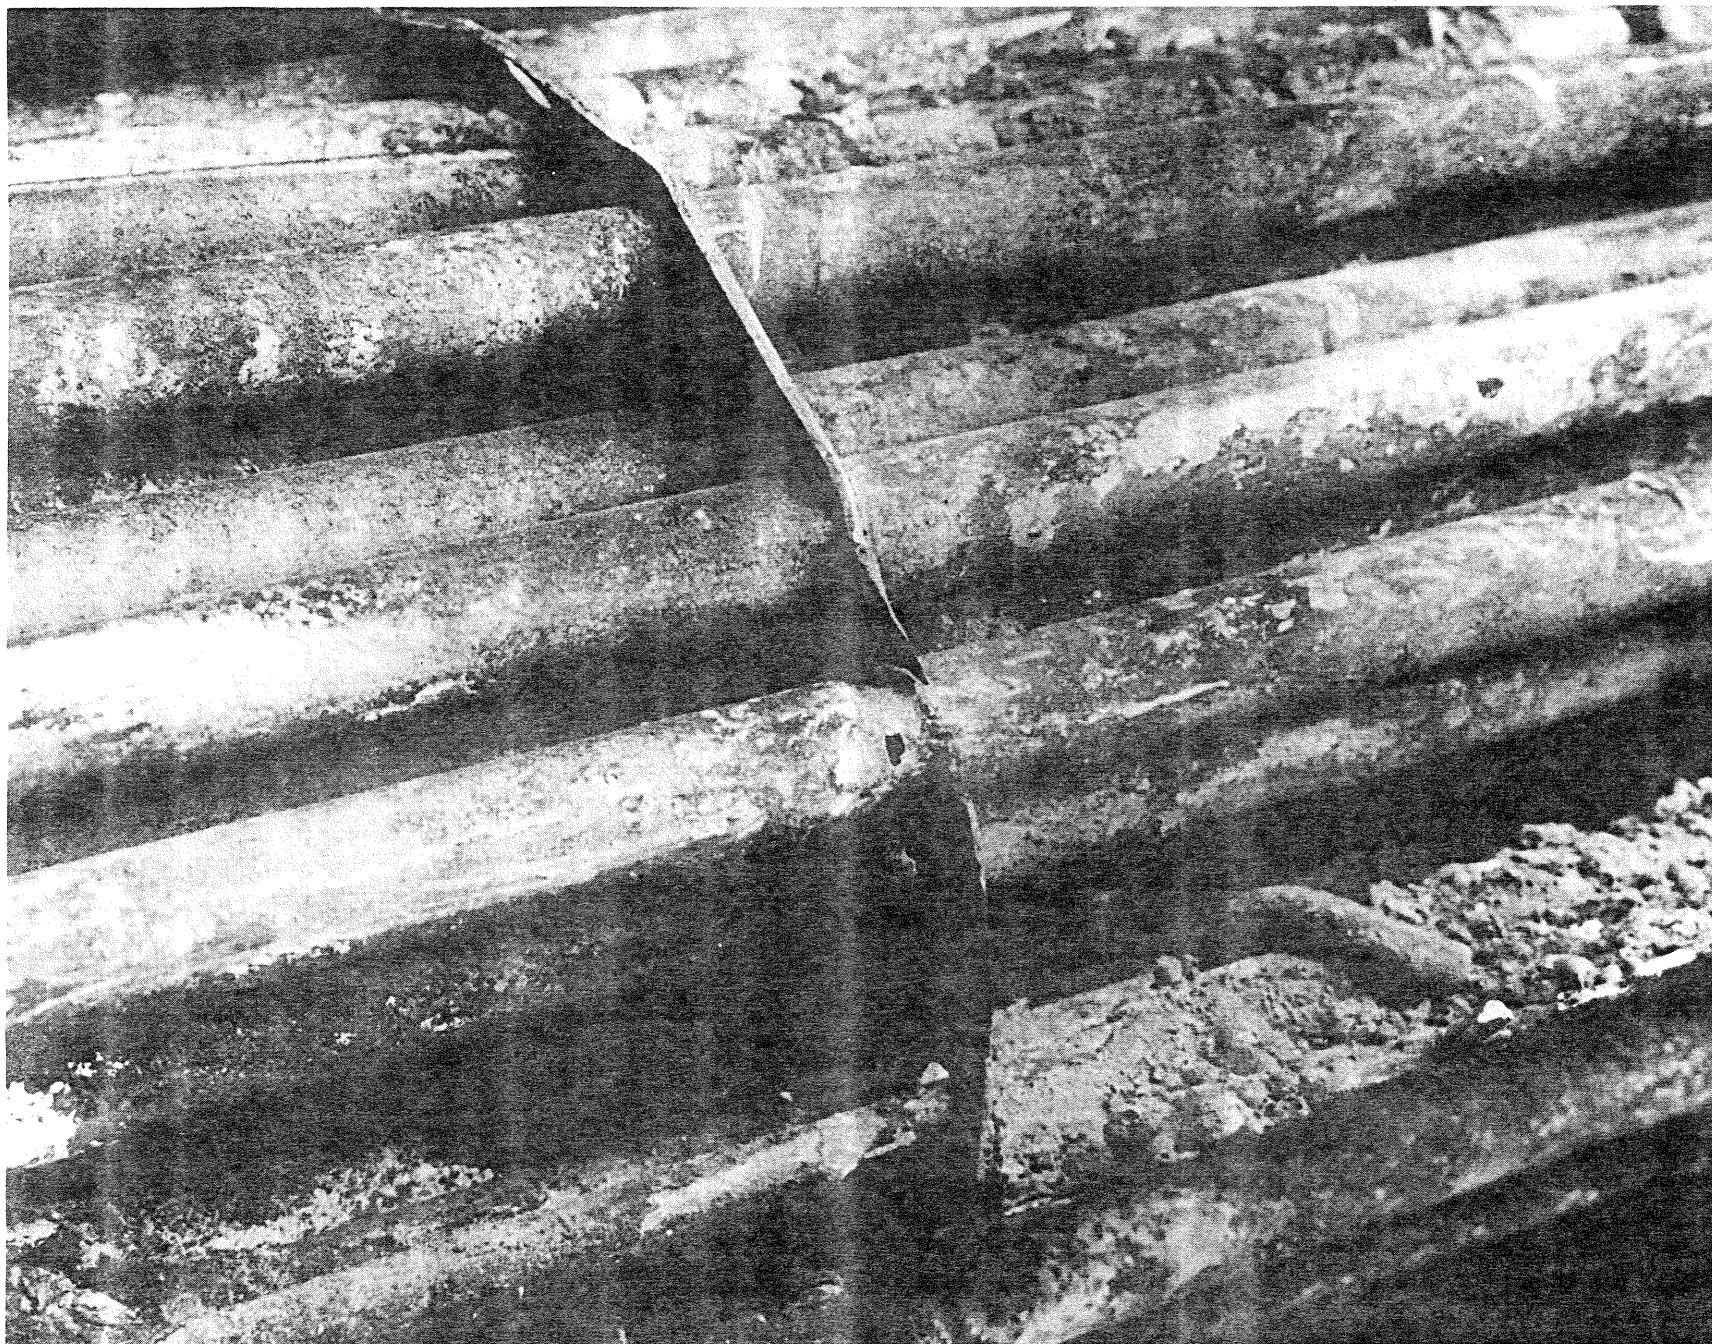
The original leak which furnished Freon for the fire appeared to have occurred where one of the tubes passed through a monel spacer sheet. At this point, the tube had a groove eroded or corroded all the way around it together with an enlarged hole in the monel sheet. With the exception of this one point the tubes appeared to have suffered little corrosion and had maintained essentially full wall thickness. The failed bundle was submitted to the Metallurgy Department for full analysis of the damage.

a) A leak in HF Condenser HFE 663A existed from some time either before start-up or immediately after start-up at 0012. Liquid Freon-114 spraying from this leak under 125 psi ignited and burned in fluorine. This is shown by the fact that a temperature rise was noted in the Freon brine system from start-up, that the fluorine was too dilute to ignite the towers, and that Freon 114-F₂ reaction products were found in the cold trap system, which had been isolated about 10 minutes before the violent reaction.

Fig. No. 7 "Necked down tube in gas cooler HFE663A. This may be the point of the original freon leak."

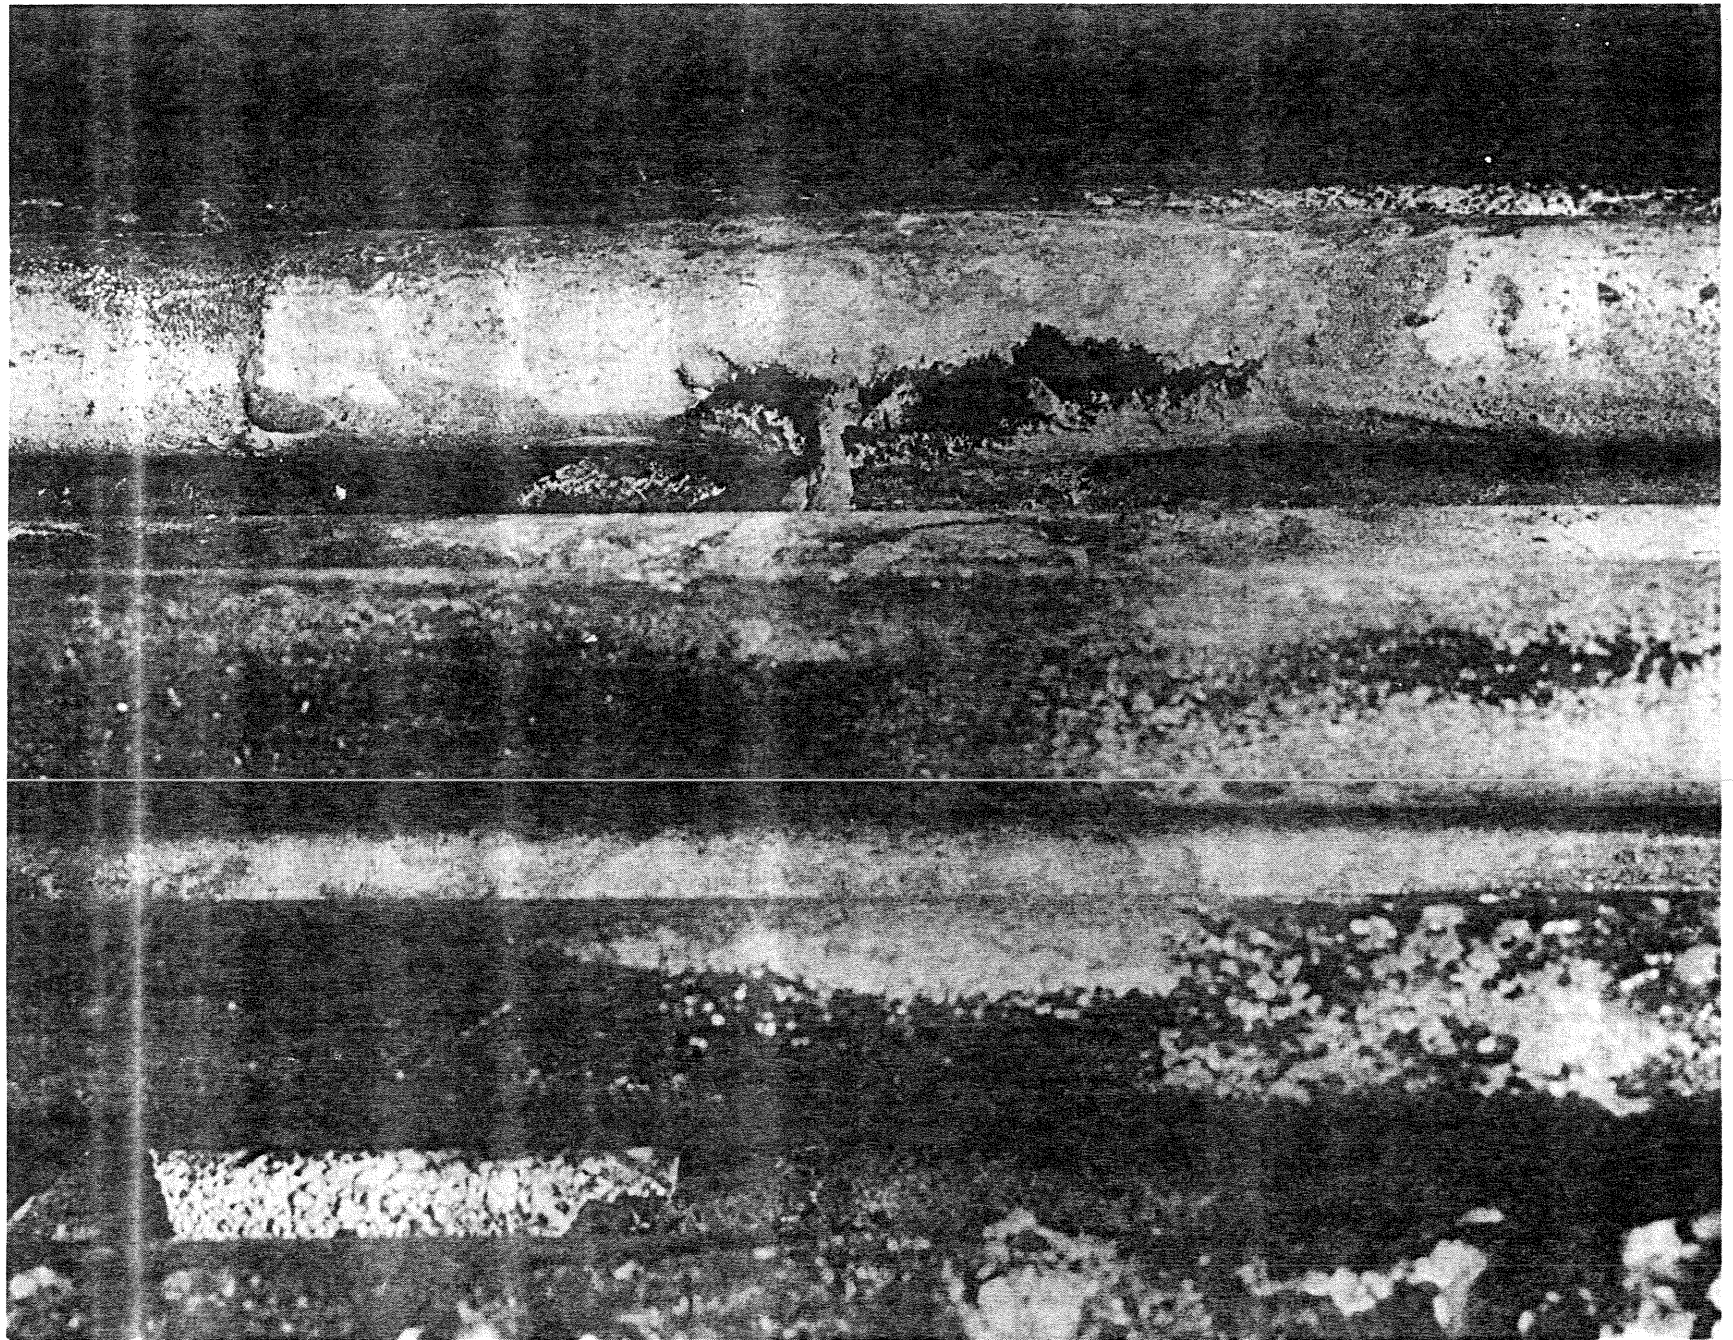
b) At about 0105 other Freon tubes in HFE 663A, heated nearly to the melting point by the fire in the condenser shell, ruptured. This flooded the condenser system with liquid Freon, which flashed to vapor at an initially semi-explosive rate as it struck several square feet of semi-molten metal, producing a pressure surge which shut off the plant through the "Q" circuit. At this time, the HF run-down tank, HFE 666A, flooded with liquid Freon.

Fig. No. 8 "Ruptured freon tube in gas cooler HFE663A."

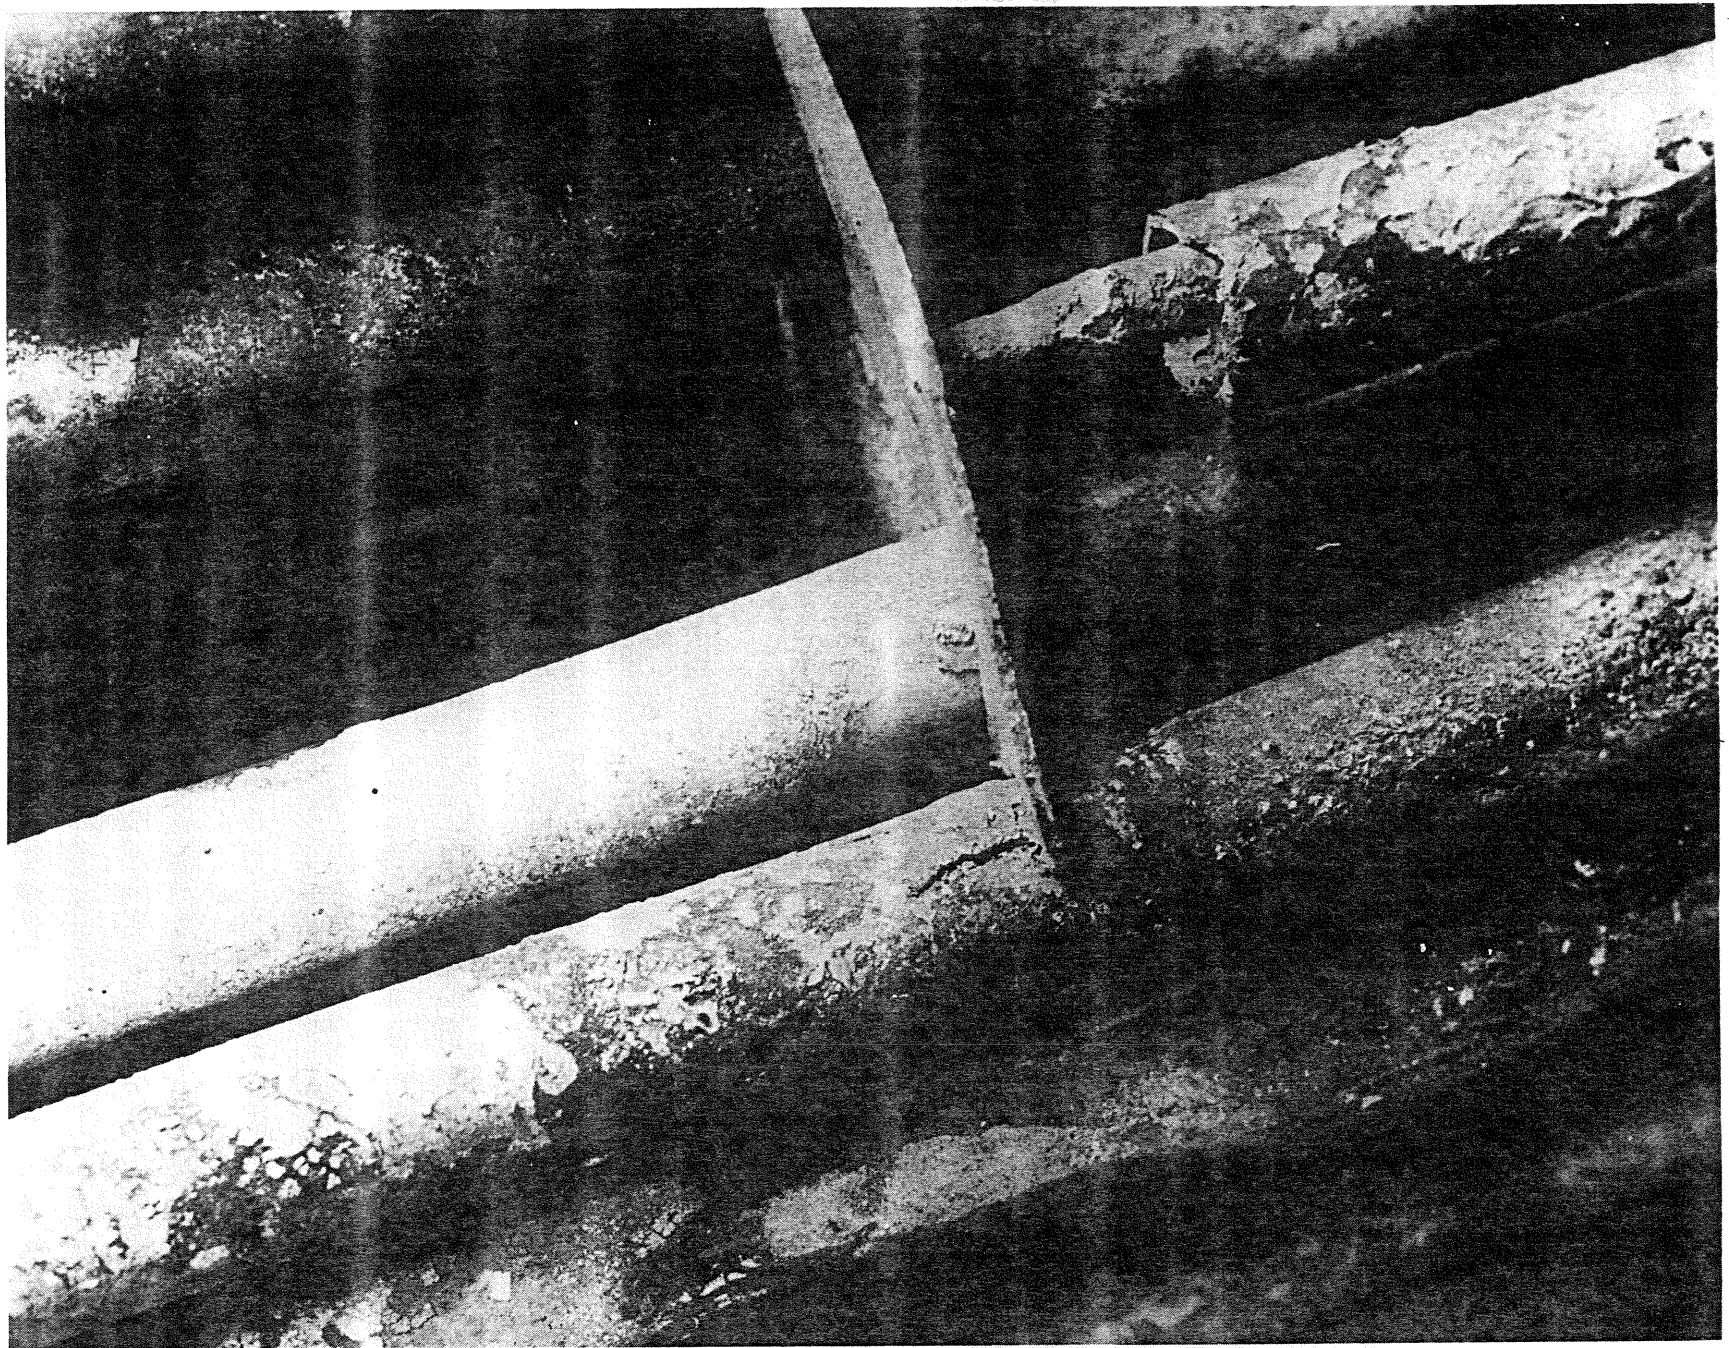
a) Reaction mechanism is discussed fully by F. E. Massoth in AEC Report, GAT-234, "Reactions of Freon-114 with Fluorine". From thermodynamic calculations it was determined that the reaction energy is approximately 300 Kcal. per mol, which is considerably larger than that for F₂ with UF₄. It appears that sufficient heat would certainly be available to produce the effects found in Cooler HFE 663A.

Fig. No. 9 "Melted tube spacers and ruptured tubes in gas cooler HFE663A."
